AFOSR ANNUAL TECHNICAL REPORT NO. 2

"Stress Corrosion Cracking of Wrought and P/M
High Strength Aluminum Alloys"

CMU Report Number: AFOSR-AL-6
Grant Number: AFOSR 81-0041
Principal Investigators: A. W. Thompson
I. M. Bernstein

1 March 1983

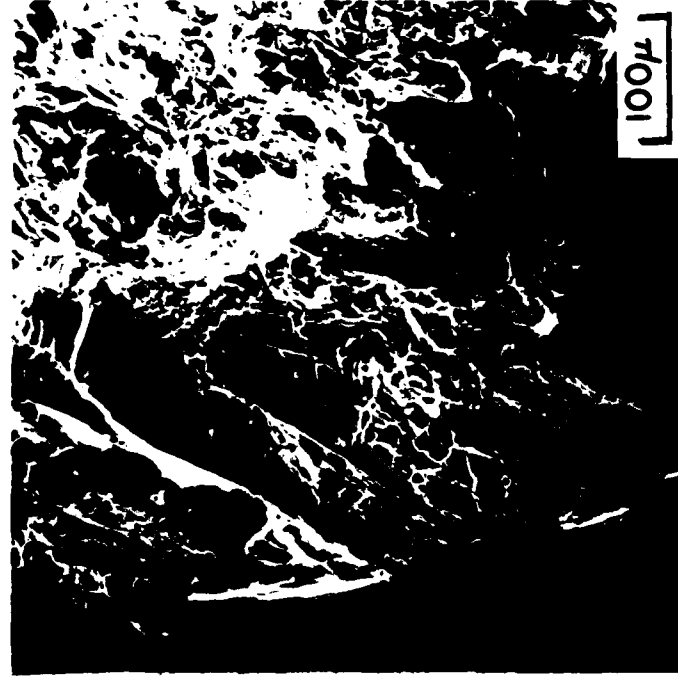
LONGITUDINAL TENSILE SPECIMENS

Underaged Temper
Straining Electrode Tests
pH 1 HCl
Cathodic Overpotential 150mV

A third test technique, hydrogen precharging, a less severe test than the SET, was also used. Notched round specimens were cathodically precharged for 10 hours in pH 1 hydrochloric acid at -1500 mV SCE and were strained to failure at crosshead rates of 0.2 mm/min. (Mode I) or 0.001 rpm (Mode III). The results of these tests are similar to those of the SET tests, but the Mode I/Mode III differences are expectedly smaller, since the precharge conditions are not as severe as those of the SET.
